**Report on Delayed Mode for Argo float WMO
1900276**

ARGO ESPAÑA - IEO / 18 - 28

**Delayed Mode Quality Control for Argo float
WMO 1900276**

January 24, 2018

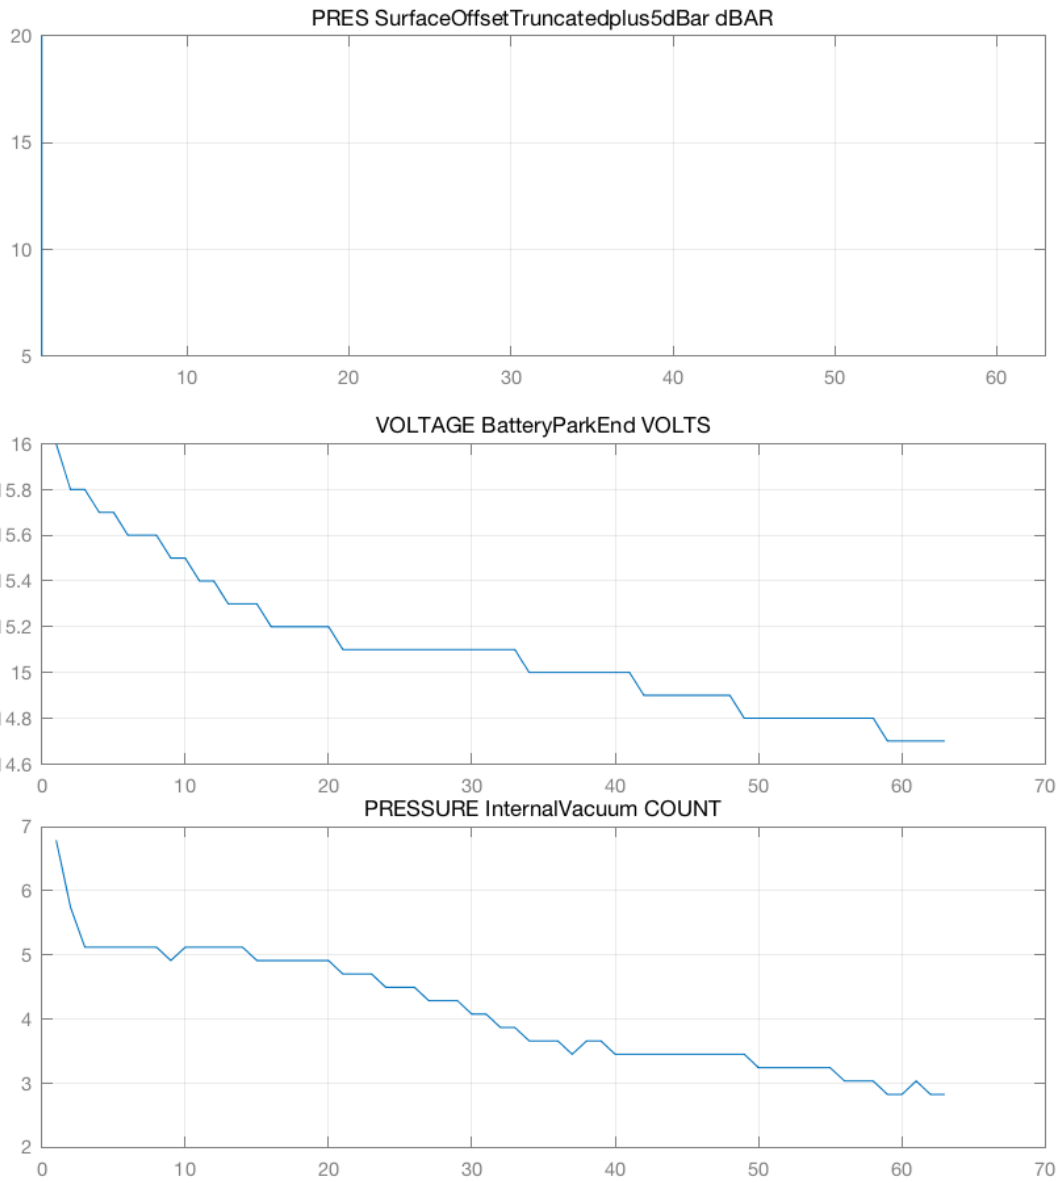
Pressure surface offset and internal vacuum malfunction was reported. There is no clear information about the mounted sensors but since the float was deployed in 2003, it might be appropriate to consider the next information about pressure sensors: "Prior 2003, Druck company has rectified some issues and the sensors were thought to be very stable, that is, until a recent discovery of a significant number of sensors now appear to suffer from a 'microleak', whereby oil leaks from the inner sensor chamber through fine cracks in the seals at the back of the sensor."

Figure 1: Pressure Surface OFFSET reported (a). Battery voltage (b). Pressure internal vacuum reported (c).

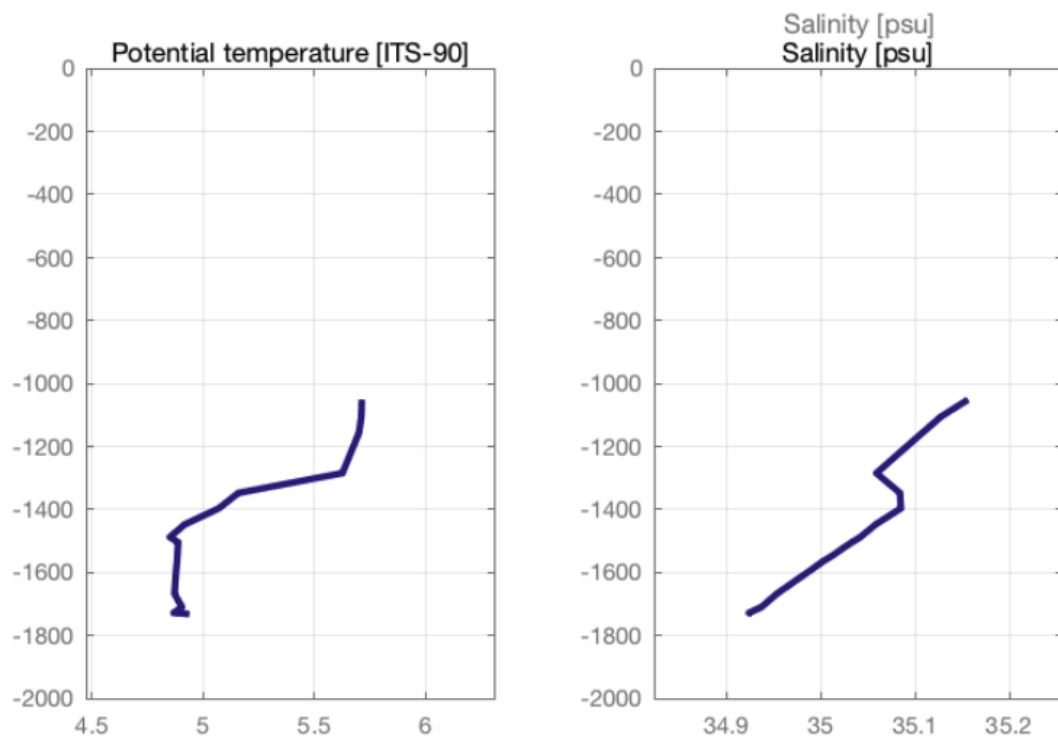
Anomalous profile (number 1) was detected during its initial analysis and discarded.

Figure 2: First anomalous profile reported.
